ATS Home
INSPECTIONS
THE INSPECTION FOR YOUR INVESTMENT

Jane Doe

ATS Sample Inspection Report

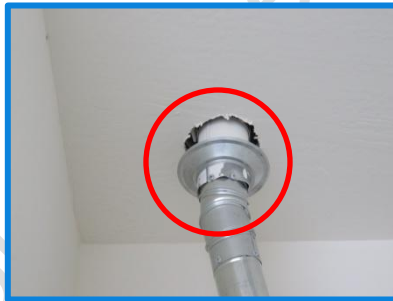
The flue collar on the water heater vent pipe is not secured to the ceiling as required. Recommendation: Secure flue collar as required.

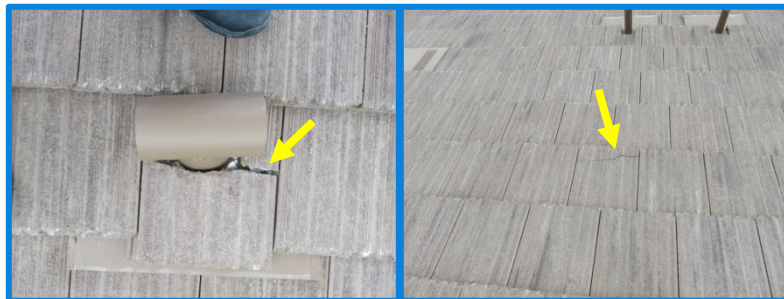
Several tiles on the roof are broken at the west slope. Recommendation: Repair as appropriate by a licensed roofing contractor.

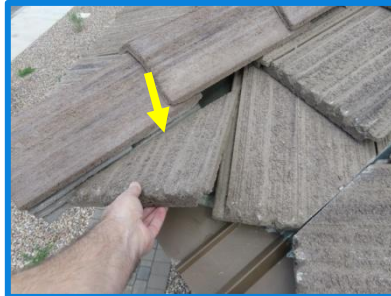
One tile at the north perimeter of the roof is not secured to the roof decking. Recommendation: Repair as appropriate by a licensed roofing contractor.

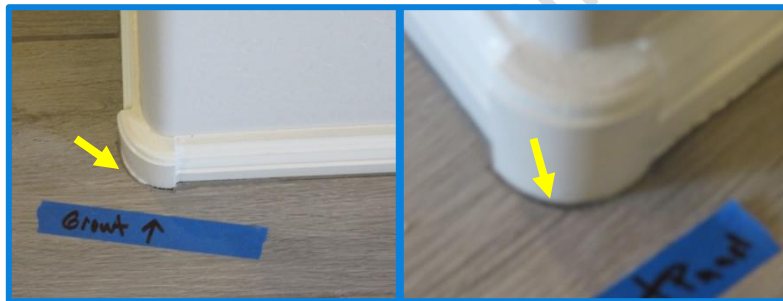
Some of the tile grout is missing or gapped at the dining room. Recommendation: Repair as appropriate.

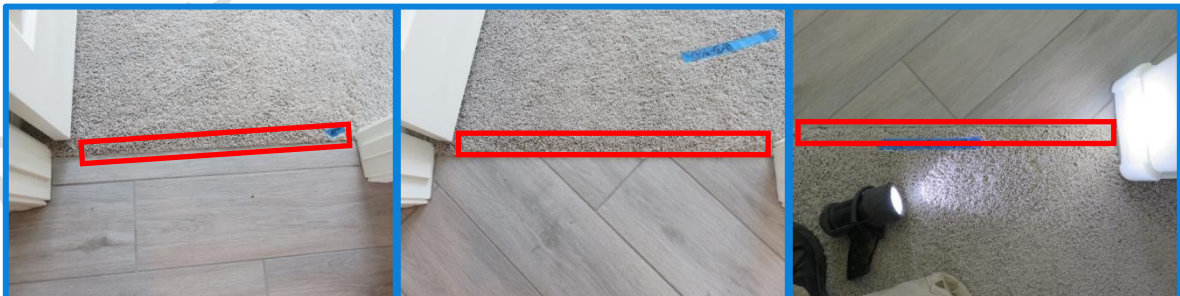
One or more of the entry ways into the bedrooms were observed to have carpet tack strips that were not properly installed. In this case when putting a light pressure down on these areas the tack strip nails could be felt. Recommendations repair as appropriate by a licensed flooring contractor.

One or more of the entry ways into the bedrooms were observed to have carpet tack strips that were not properly installed. In this case when putting a light pressure down on these areas the tack strip nails could be felt.

Recommendations repair as appropriate by a licensed flooring contractor.

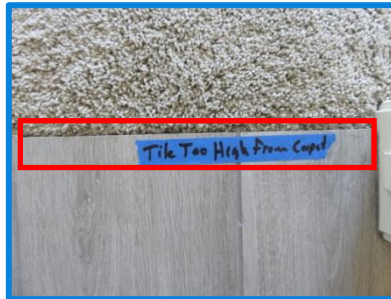
At the time of the inspection I notated the tile flooring in the master bedroom was set to high and may present a trip hazard. Recommendations repair as appropriate by a licensed flooring contractor.

At the time of the inspection I notated the tile flooring in the master bedroom was set too high and may present a trip hazard. Recommendations repair as appropriate by a licensed flooring contractor.

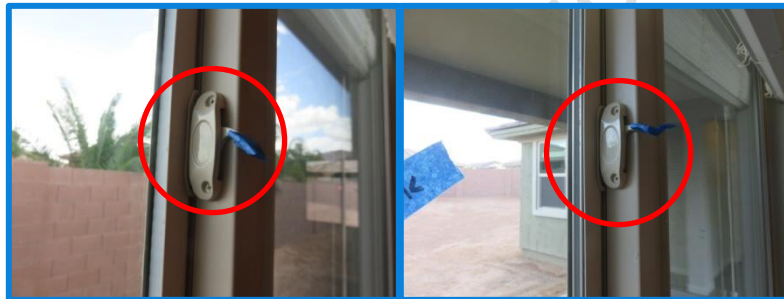
One of the windows locking hardware is out of adjustment at the dining room (east) and living room (south), thus preventing the affected windows from being latched. Recommendation: Repair as appropriate by a licensed window contractor.

One of the windows locking hardware is out of adjustment at the dining room (east) and living room(south), thus preventing the affected windows from being latched. Recommendation: Repair as appropriate by a licensed window contractor.
